**National Highway
Traffic Safety
Administration**

Case Vehicle (A): 1999 Chevrolet
Type: Silverado, 4x4 extended cab pickup
Driver: 65-year-old male
CDC: 02-FDEW-2, 03-RZEW-2, 00-TDYO-3

Vehicle (B): 1996 Chrysler
Type: Concorde, 4-door sedan
Driver: 79-year-old male
CDC: 11-LYEW-4, 09-LZEW-2

GENERAL VEHICLE DAMAGE AND ESTIMATED CRASH SEVERITIES

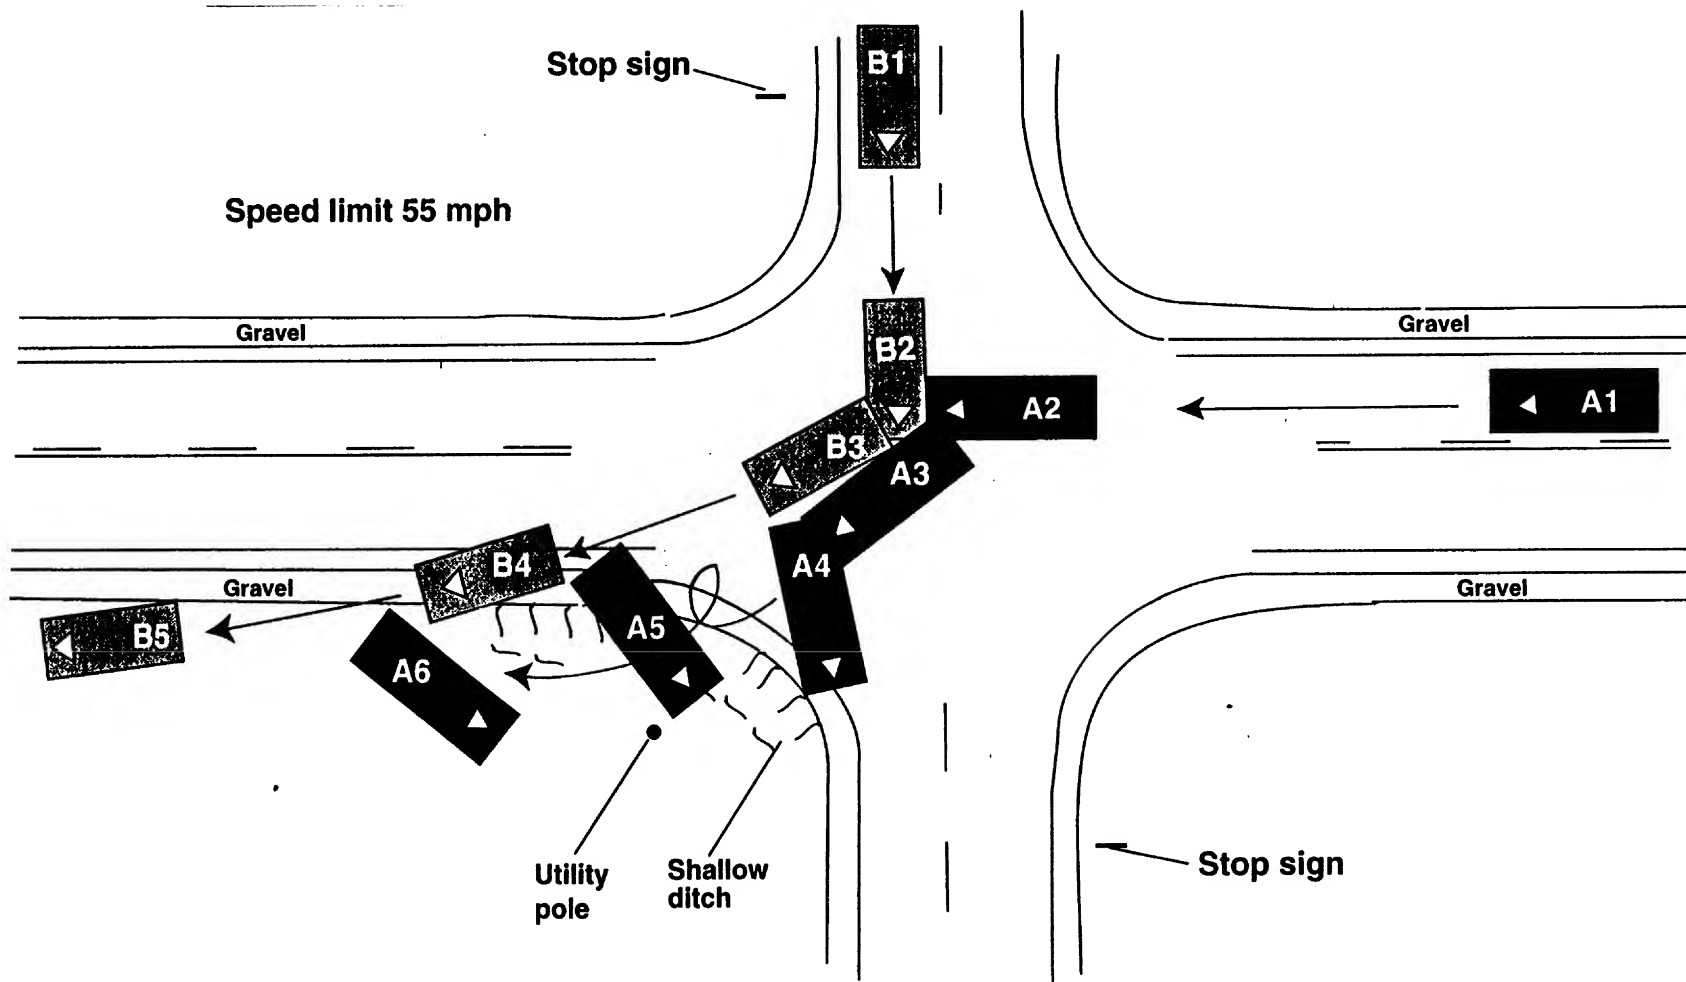
ACCIDENT SCHEMATIC

ACCIDENT DESCRIPTION: Case vehicle (A) was traveling westbound on a 2-lane roadway, approaching a 4-leg intersection. Vehicle (B) was traveling southbound on the intersecting 2-lane roadway. As case vehicle (A) entered the intersection, vehicle (B) also entered the intersection and crossed the path of case vehicle (A). Case vehicle (A) struck the left side of vehicle (B) with its front end. The impact caused vehicle (B) to enter a clockwise rotation and case vehicle (A) to enter a counterclockwise rotation, resulting in a side-slap impact between the two vehicles. Vehicle (B) crossed the eastbound traffic lane and exited the intersection through the west leg, departed the roadway and came to a rest. Case vehicle (A) departed roadway where it tripped, right side leading a rolled 4-quarter turns. Case vehicle (A) came to rest on its wheels at the southwest corner of the intersection.

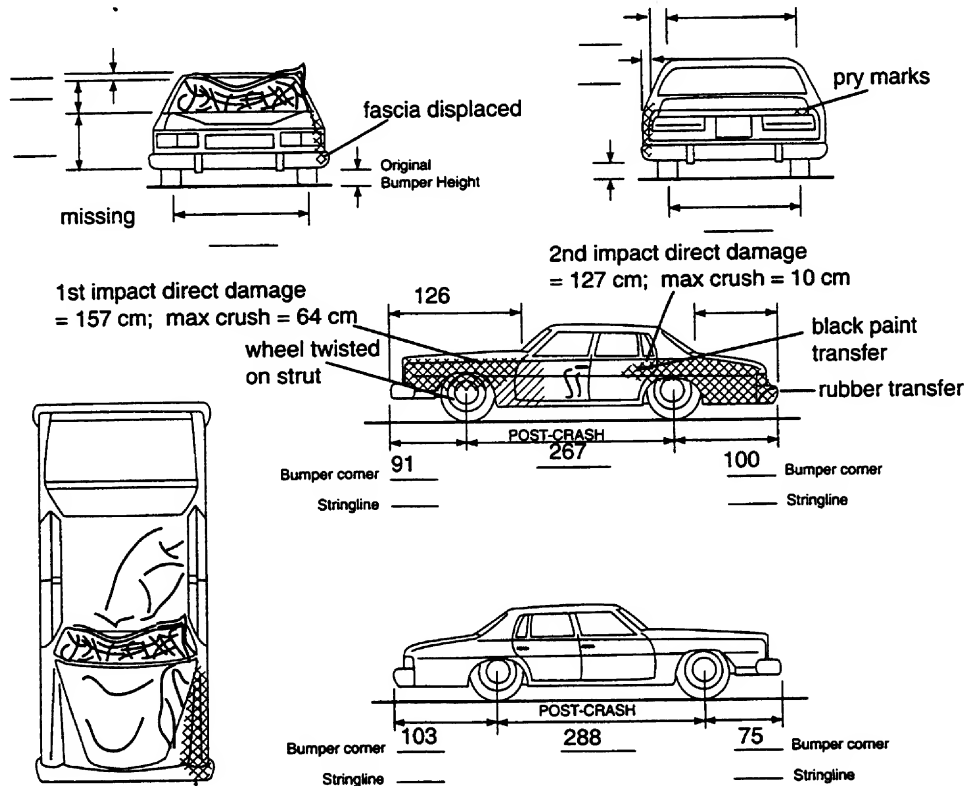
Wheelbase	<u>287</u> cm	Front Overhang	<u>115</u> cm
Curb Weight	<u>1573</u> kg	Rear Overhang	<u>110</u> cm
Average Track Width	<u>158</u> cm	Undeformed End Width (UEW)	<u>150</u> cm
Overall Length	<u>512</u> cm	Engine Displacement	<u>3.3</u> L
Overall Width (OAW)	<u>189</u> cm	Engine: # of Cylinders	<u>06</u>

Cargo: 15 kg Golf bag/clubs

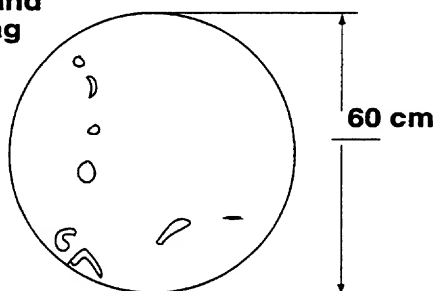
Driver Airbag

Blood drops
on front and
rear of bag

Vents: ☒ N
if yes, how many: 2

Tethers: ☒ N
if yes, how many: 2

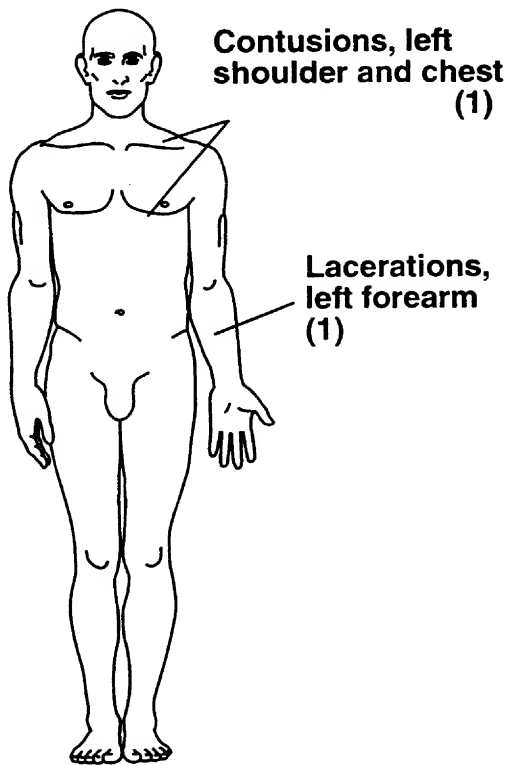
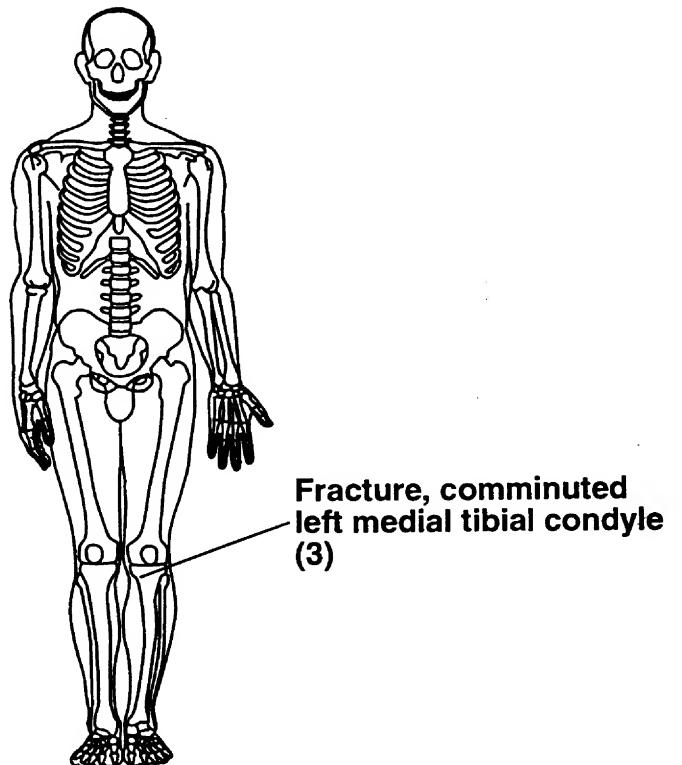
INDICATE LOCATION OF INJURIES.

Injury Description	A.I.S.	Injury Source		
		Definite	Probable	Possible
Contusion, left shoulder	1	Shoulder belt		
Contusion, left side of chest	1	Shoulder belt		
Laceration, left forearm	1			Unknown
Laceration, left forearm	1			Unknown
Fracture, comminuted left medial tibial condyle	3	Knee bolster		
<u>Maximum A.I.S. Level</u>	<u>3</u>			
<u>Injury Severity Score</u>	<u>10</u>
